SPECIAL AIRWORTHINESS INFORMATION BULLETIN

CE-04-54
February 26, 2004

This Special Airworthiness Information Bulletin advises you, owners and operators of **Tiger Aircraft LLC (American General) AG-5B aircraft**, of throttle cable failure. Tiger has revised their Aircraft Maintenance Manual (AMM), dated September 2003. They have included a recommendation that **operators replace the throttle cable at each engine overhaul or when the rubber grommet dust cover (Figure 1) shows signs of deterioration (cracking or dry rot)**. Failure to replace the throttle cable could lead to loss of engine power.

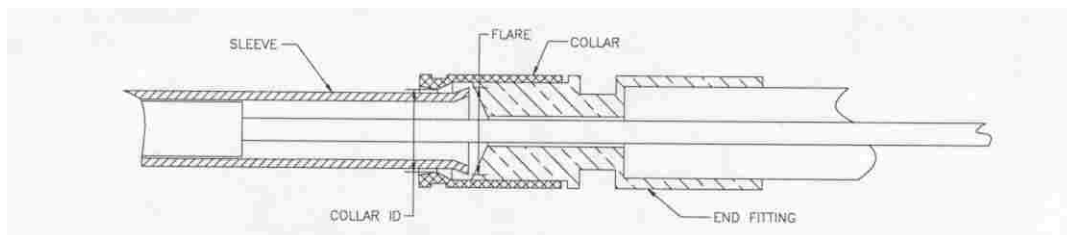
Figure 2
Cross Section of Swivel (grommet not shown)

Tiger Aircraft revised the AMM and added the throttle cable replacement recommendation based on reports of throttle cable failure and binding. During inspection of failed throttle cables they noted that the sleeve on the engine compartment side of the cable had pulled loose at the swivel point of the cable. The subject sleeve is flared on one end and fits into a mechanical collar, which is swaged onto the end fitting of the cable (Figure 2). A rubber grommet covers this area to prevent contamination from dust, dirt, and other foreign matter. This rubber grommet may deteriorate over time and allow contaminants to enter the area. This condition could promote wear leading to eventual failure of the throttle cable.

- During each scheduled check of the throttle operation, you should inspect the rubber grommets for deterioration. The throttle cable is equipped with 2 rubber grommets on its engine compartment end. If deterioration is evident, you should replace the throttle cable.
- You should replace the throttle cable at engine overhaul regardless of grommet condition.
